SCRUTINEER'S BULLETIN

March 2019 (160)

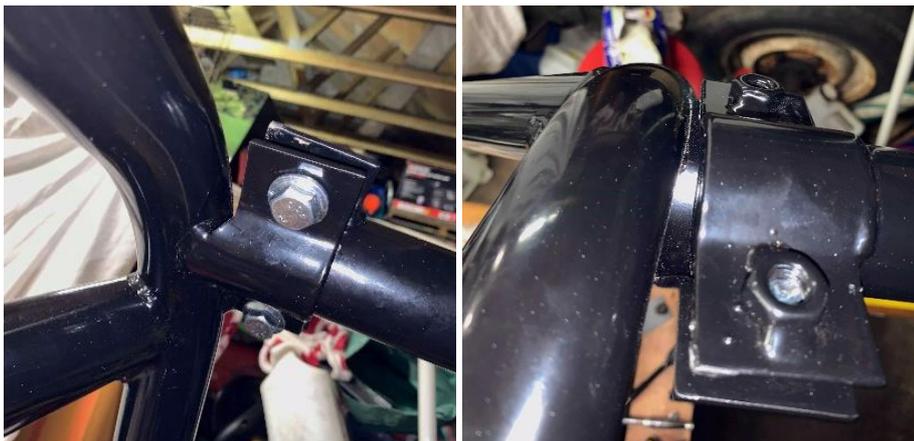
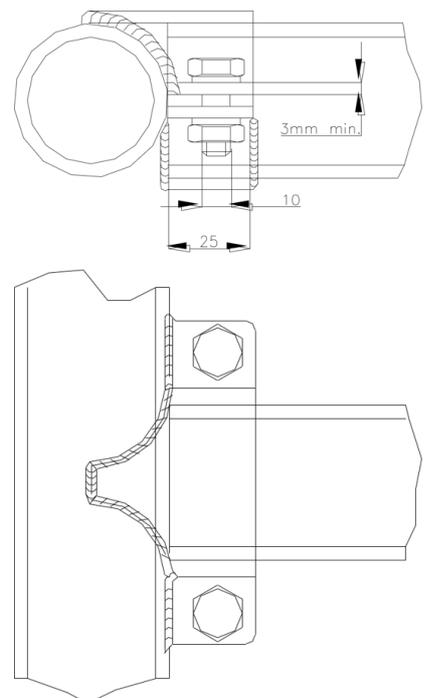
The first 2 photos below were forwarded on to us by a concerned Scrutineer who encountered this ROPS fitted in car presented for inspection. The Scrutineer was rightly concerned about the quality and integrity of the dismantable joints used in the construction of the ROPS and rejected it on this basis.

The joint appears to be a vague attempt to follow the principle of the allowable dismantable joint in Motorsport UK Yearbook drawings (K)21-22 (or FIA drawing 253-37 shown to the right). However, it falls way below an acceptable standard for a number of reasons. The part of joint attached to the roll hoop is nowhere near being fully welded along its whole contact surface. The part of the joint

attached to the end of the tube is not welded around the 'open' end, which is related to the fact that the tube is also not flush with the edge of the joint piece, which is important as it is then not clear how much of the tube is actually being compressed by the joint once tightened. And the bolts used are clearly too short as not only are there no exposed threads through the nut as we would expect to see, but it looks as though the bolt is only turned a few threads into the nut! Each of these factors alone clearly contravenes the way the joint should be fabricated and utilised according to the drawing.

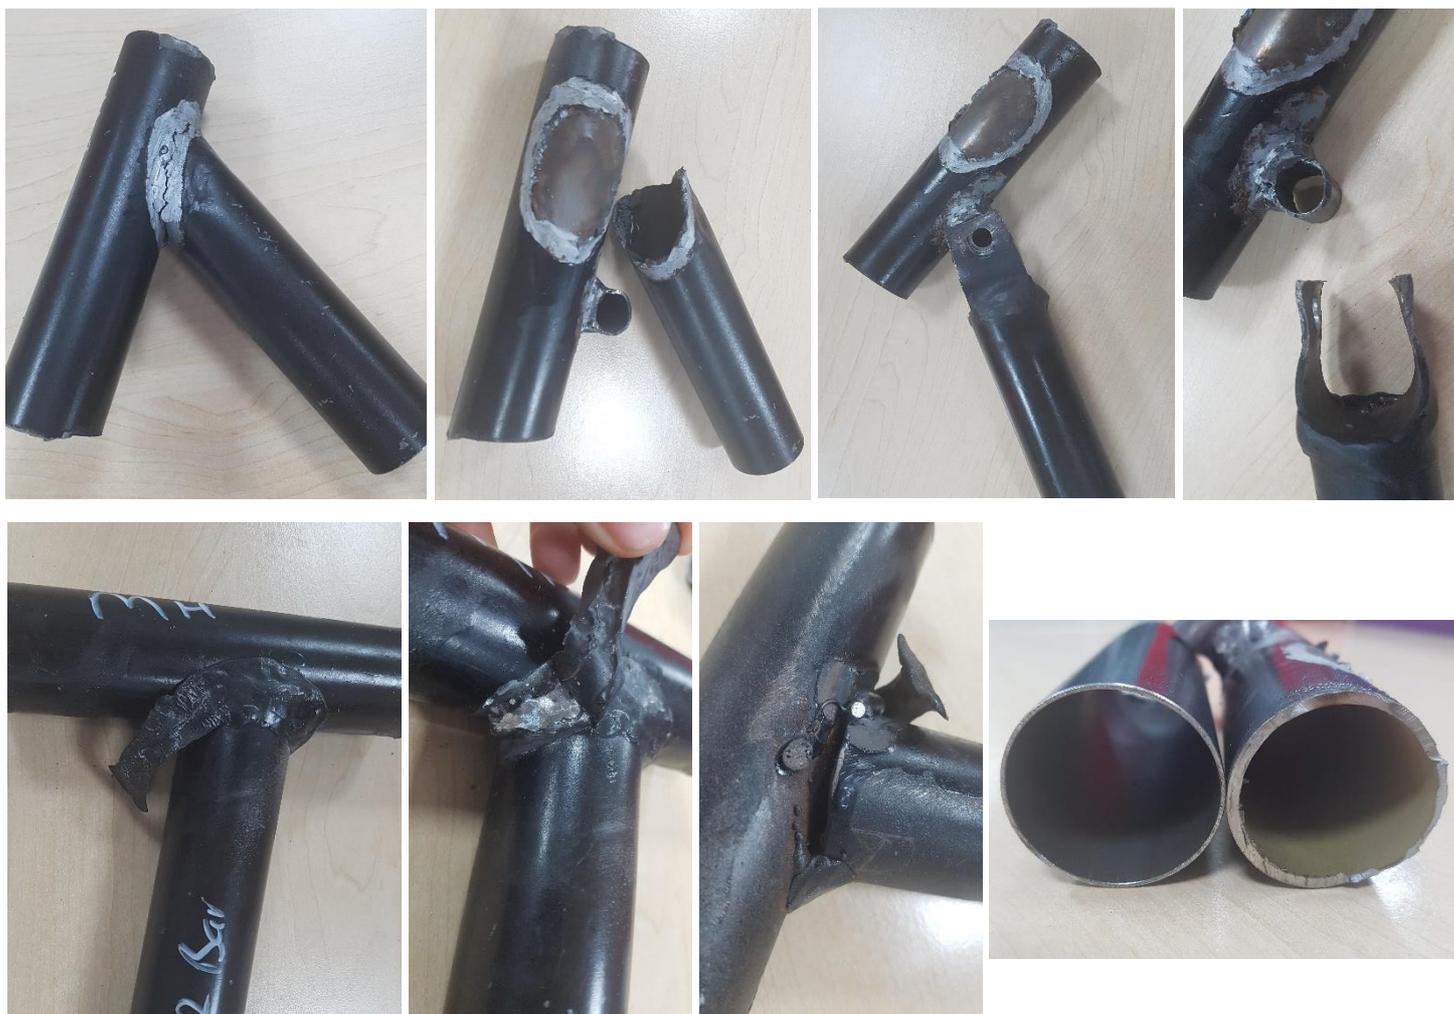
The next series of photos barely need any explanation! These examples were provided to us by a reputable ROPS manufacturer, and are taken from a ROPS (not one of theirs!) that arrived in their workshop for some work. It didn't take long to establish that something was not right and was soon clear that a number of additions had been made to what appeared to be a fairly standard main hoop – these additions were made of tube with the same outside diameter but very low wall thickness. They were also not welded anywhere near satisfactorily, with significantly incomplete welds, poor penetration and generally very messy appearance, with the one example below being verily easily pulled apart by hand. There was also a very badly fashioned dismantlable joint in use. However, perhaps the most alarming discovery was that most of these badly welded joints were covered with putty prior to painting! A reminder to look carefully and dig a little deeper if something doesn't seem quite right!

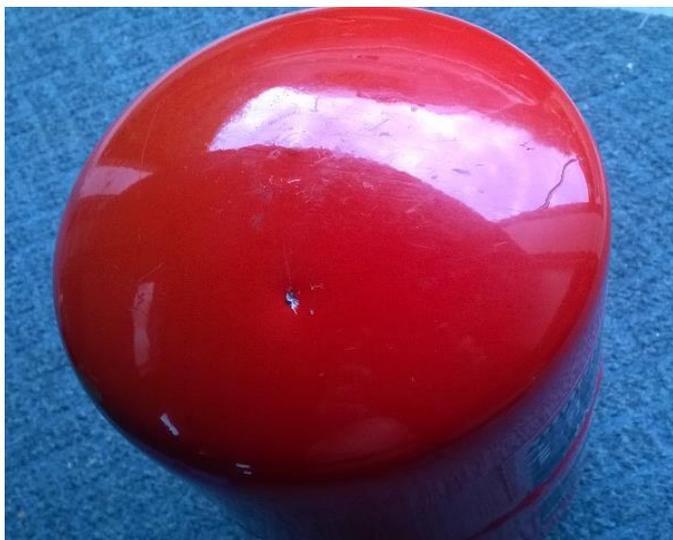
The picture of the extinguisher was sent in to us by a Scrutineer, with what appears to be minimal damage. It was found when the bottle was being serviced that the small mark on the base had caused a sharp pimple on the inside of the body causing additional pressure stretching the bladder, and the bottle was about to burst! This leads on to say that it's important to check for even the smallest amount of damage to bottles as knocks to the outside can cause damage inside also, potentially leading to serious consequences.
